**THAMES RIVER BASIN
LEBANON, CONNECTICUT**

**WILLIAMS POND DAM
CT 00551**

**PHASE 1 INSPECTION REPORT
NATIONAL DAM INSPECTION PROGRAM**

OCTOBER 1978

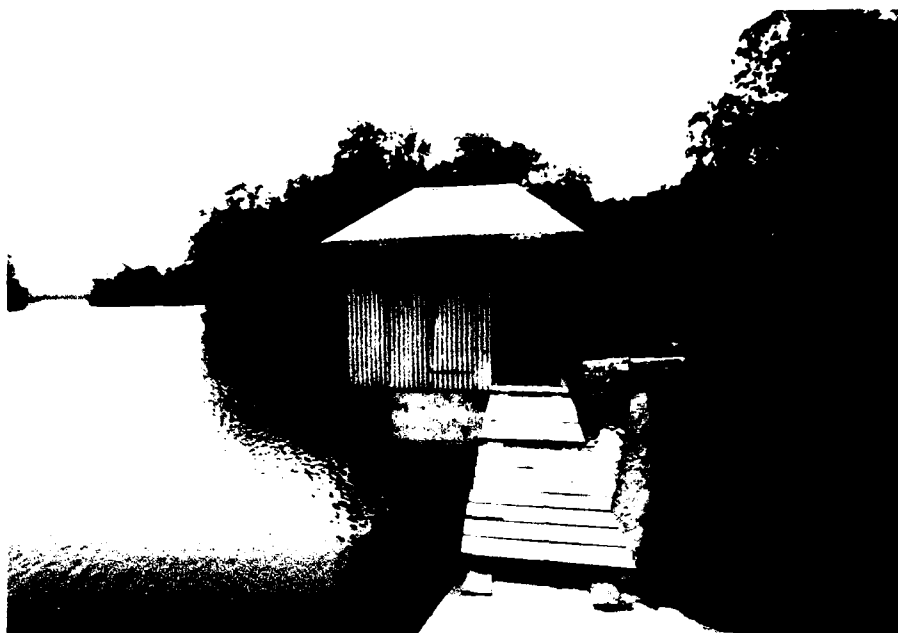
The access bridge to the gatehouse should be closely monitored during high flows to prevent floating debris from accumulating along its length. This accumulation has the potential to increase flooding or to damage the bridge and result in loss of gate control. See Photo C-2.

C-2 SPILLWAY AND GATEHOUSE (LOOKING FROM THE RIGHT ABUTMENT TO THE LEFT.)

3. The access bridge to the outlet works gate should be monitored and kept in serviceable condition. It should be noted that the bridge will act as a debris collector and should be monitored particularly during high flow periods to ensure that floating debris will not overload it or that it will not be damaged, causing loss of control of the gate.

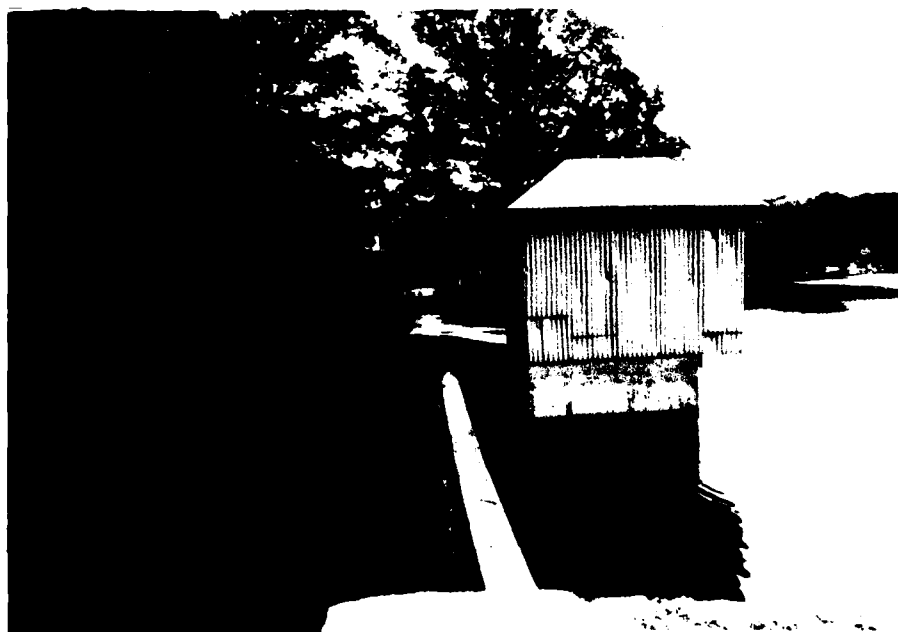
C-3 SPILLWAY AND GATEHOUSE (LOOKING FROM LEFT ABUTMENT TO RIGHT ABUTMENT.)

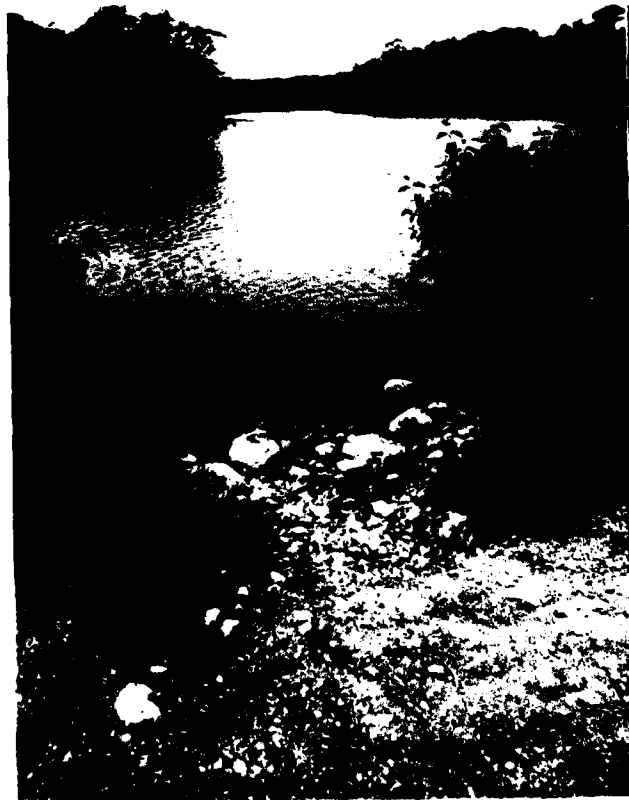
pond, exposing the dike soil directly to wave action. There is no filter material present between the rubble stone and the dike soil. Wave action, erosion and trespassing have combined to cause several zones at which a considerable portion of the crest of the dike has been eroded. In one location the erosion has proceeded to such an extent that the crest width is practically zero over a length of about 10 feet.

C-11 TYPICAL SURFACE
EROSION AT DIKE FROM
TRESSPASS.

- c. Design new riprap protection for the upstream face of the dike and restore the full cross section of the dike.
- d. Provide recommendations for removal of stumps and roots that presently exist on the embankments and for replacing the roots with properly selected and compacted soils.

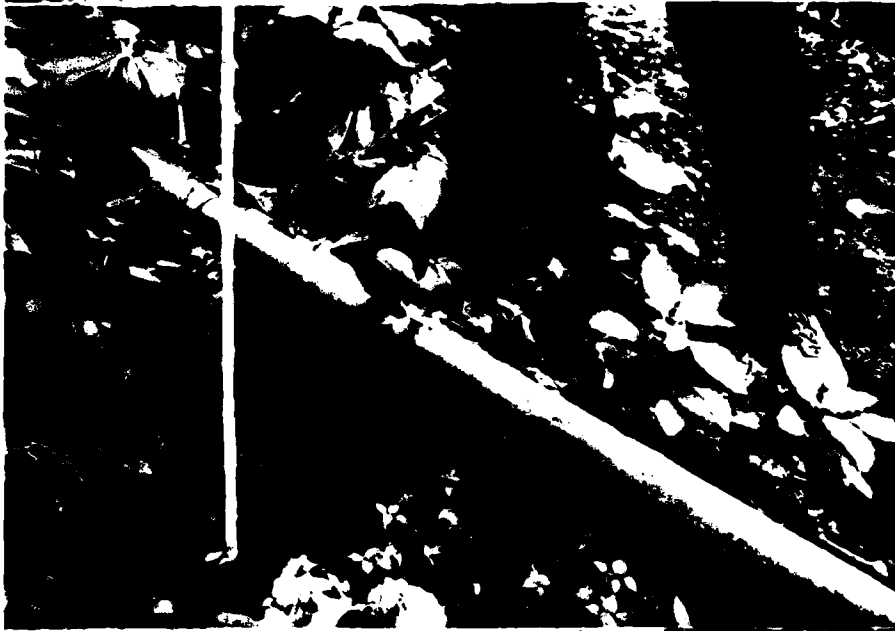
Seepage is occurring through and under the embankments on the left and right sides of the spillway, at the spillway-bedrock interface, and possibly through the left and right abutments or foundation soils. At the time of visual inspection, the seepage water was clear. The evidence for the seepage is the presence of mushy zones 10 to 20 ft. downstream from the dam just to the left and right of the spillway, as may be seen in Photograph C-6, 7, 12 and as shown in Appendix B-3.

C-12 SEEPAGE AT RIGHT ABUTMENT.
